03 - POST-CONSTRUCTION MONITORING OF CULVERT CROSSINGS OF WATERCOURSES IN SACs

Abstract

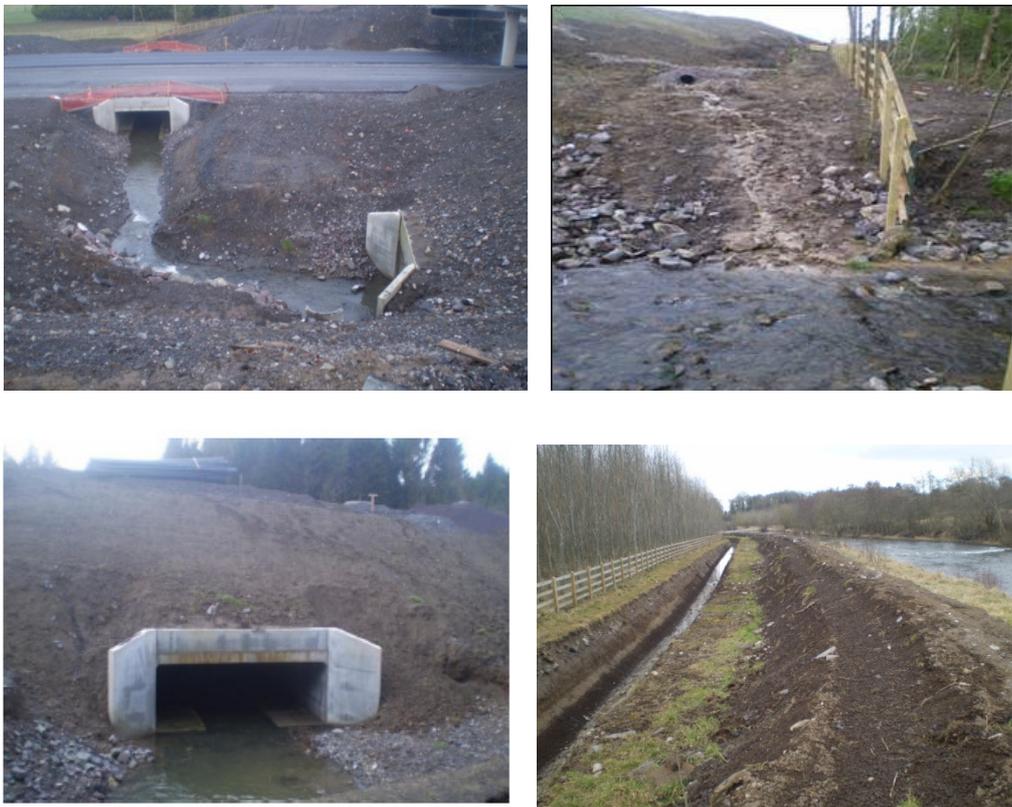
Figure 2: Earthworks associated with culvert and drainage construction illustrating SS transport to adjacent watercourses – M3 motorway

The primary water quality parameter that is likely to be impacted from motorway earthworks and drainage is the suspended solids concentration of adjacent watercourses, arising from sediment transport, as illustrated in Fig. 2. Regulatory agencies generally attempt to control sediment input into watercourses by placing a limit on suspended solids (SS) or turbidity, specified as either absolute values, or permissible exceedances above natural background levels.

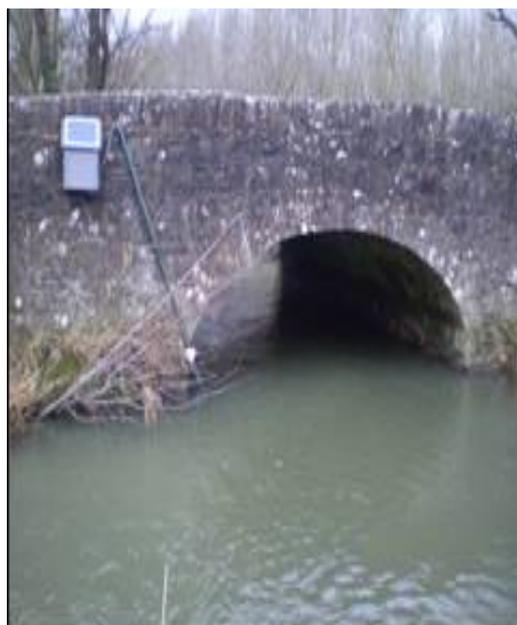
Figure 3: (a) Real-time water quality monitoring; (b) Typical water quality data, River Boyne tributary M3 motorway

The water quality monitoring programme encompassed physico-chemical and biological water quality analyses. Manual sampling and real-time water quality monitoring was undertaken. Examples of suspended solids concentrations recorded at the sampling points on a quarterly basis are presented in Table 1. The corresponding biological water quality, as measured by the EPA biotic index, is presented in Table 2. Examination of Table 1 and Table 2 shows that, although there were occasional spikes in SS concentrations, the biological quality of the water does not appear to have been significantly impacted. The real-time water quality monitoring station at a River Boyne tributary is illustrated in Fig. 3(a) and sample data is presented in Fig. 3(b).

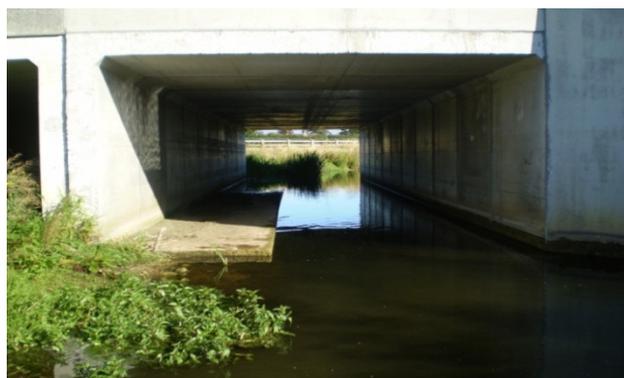
Some examples of culvert designs are illustrated in Figs. 11, 12, 13. Fig. 11 shows a twin-box culvert crossing of the M3 motorway with what would appear to be a concrete ledge that is inaccessible to mammals from the bank and partially drowned, even in dry weather. Fig. 12 shows a box culvert crossing of the M7 motorway with a galvanised steel ledge accessible to mammals and in compliance with NRA width and headroom requirements. Fig. 13 shows an arched culvert crossing of the M9 motorway, showing an example of best practice re. mammal passage, providing a ‘walkable’ ledge using natural materials and good approach conditions. A summary of ‘snags’ identified in 18 culverts surveyed and the ‘openness ratio’ for these culverts is presented in Fig. 14 and Fig. 15 respectively.

Figure 11: M3 twin-box culvert with concrete mammal ledge

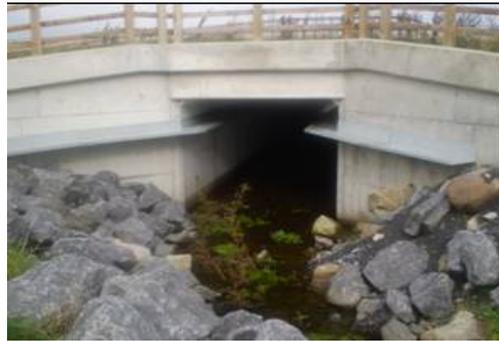
Figure 12: M7 box culvert with galvanised steel mammal ledge

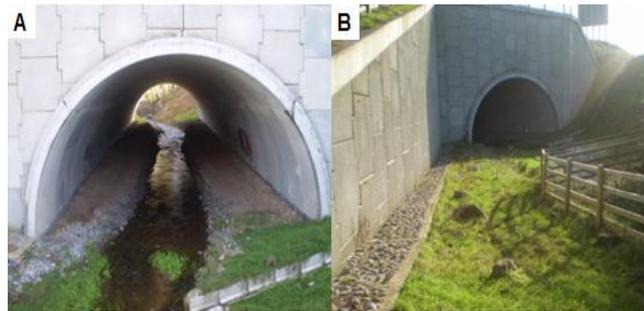
Figure 13: M9 arch culvert with stone mammal ledge
